Manhole Inspection Summary

Manhole # S21I1_020MH

Location Address: **2511 brohawn av**

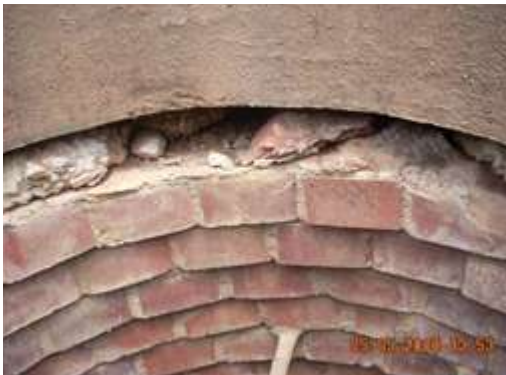
Defect 2

Condition: ☐ Sound ☐ Cracked ☐ Root Intrusion ☐ Loose Brick ☒ **Deteriorated**

deteriorated chimney

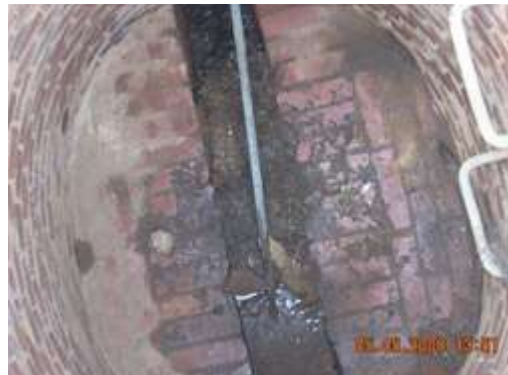
Defect 1

Condition: ☐ Sound ☐ Cracked ☐ Root Intrusion ☐ Deteriorated ☐ Leaks ☒ **Debris**

debris in channel

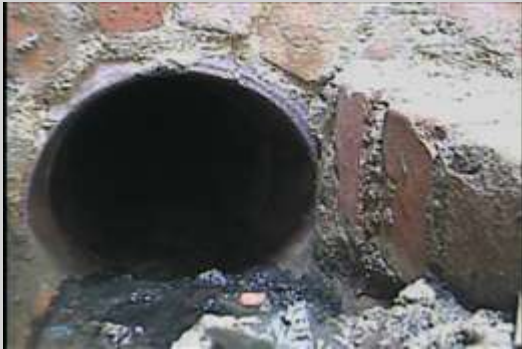
12 O'Clock Outflow

8 in. Circular Gravity Sewer
Pipe Out @ 12 O'Clock

Pipe Height: **8.4** (in.) Rod and Bar (Angled)
Pipe Material: **Clay** ☐ Pipe Lined
Invert Depth: **7.29** (ft.) Flow Characteristics: **Slow**
Deposits: ☐ None ☒ **Mud** ☐ Sludge ☒ **Debris** ☐ Grease
Silt Depth: **1** (in.) Deposits Extent: **Light**
Infiltration: **None** Pipe Seal Cond: **Sound**

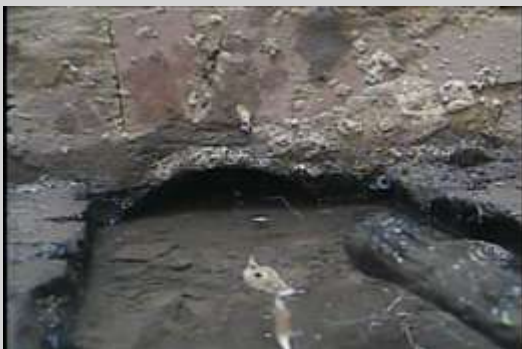
6 O'Clock Inflow

8 in. Circular Gravity Sewer
Pipe In @ 6 O'Clock

Pipe Height: **7.2** (in.) Rod and Bar (Angled)
Pipe Material: **Clay** ☐ Pipe Lined
Invert Depth: **7.09** (ft.) Flow Characteristics: **None**
Deposits: ☐ None ☒ **Mud** ☐ Sludge ☒ **Debris** ☐ Grease
Silt Depth: **7** (in.) Deposits Extent: **Heavy**
Infiltration: **None** Pipe Seal Cond: **Sound**
